16th International Conference on
Alkali-Aggregate Reaction in Concrete
Lisboa | LNEC | Portugal | 31 May - 2 June 2022

Technical Visit
3 to 5 June 2022

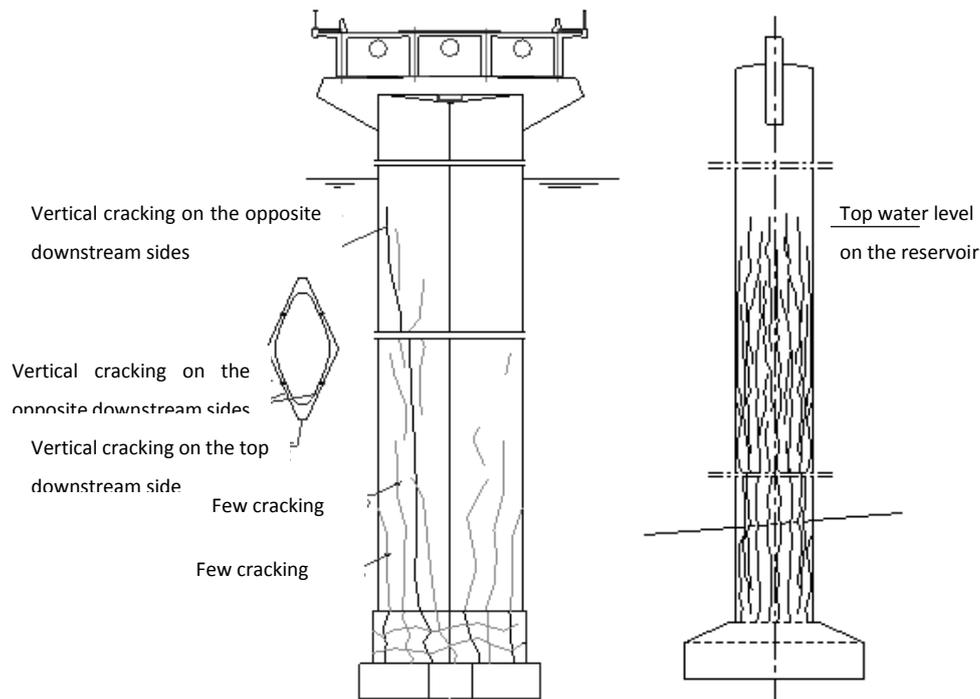
The laboratory tests, conducted on those studies, diagnosed both Alkali-Aggregate Reaction (AAR) and Internal Sulphate Reaction (ISR) due to Delayed Ettringite Formation (DEF) as the causes of deterioration, as mentioned in (Santos et al., 2022). The results of the tests performed by LNEC showed that the deterioration mechanism led to a significant change in the concrete mechanical properties, particularly the elasticity modulus, which conducted to the structural rehabilitation and reinforcement of 6 bridges and the replacement of Foz do Dão bridge, which was intensely deteriorated (Fig. 6).

Figure 6 - Cracking observed on Foz Dão bridge piers (in Rodrigues et al., 2022).

- Several cracks in piers foundation, particularly at the basement level, with random orientation;
- Vertical cracking, mainly in the pier/basement connection, over all the piers perimeter, with uniform spacing;
- Vertical cracking in the piers shaft, with some spot zones with steel corrosion and deficient concrete joints.

The design of piers and foundations strengthening was based on the assumption that it was possible to maintain the decks, and that this approach was more competitive, in economic terms, than the integral replacement of the bridges. Only for the Foz do Dão bridge was verified to be more advantageous, in technical and economic terms, the integral bridge replacement solution.

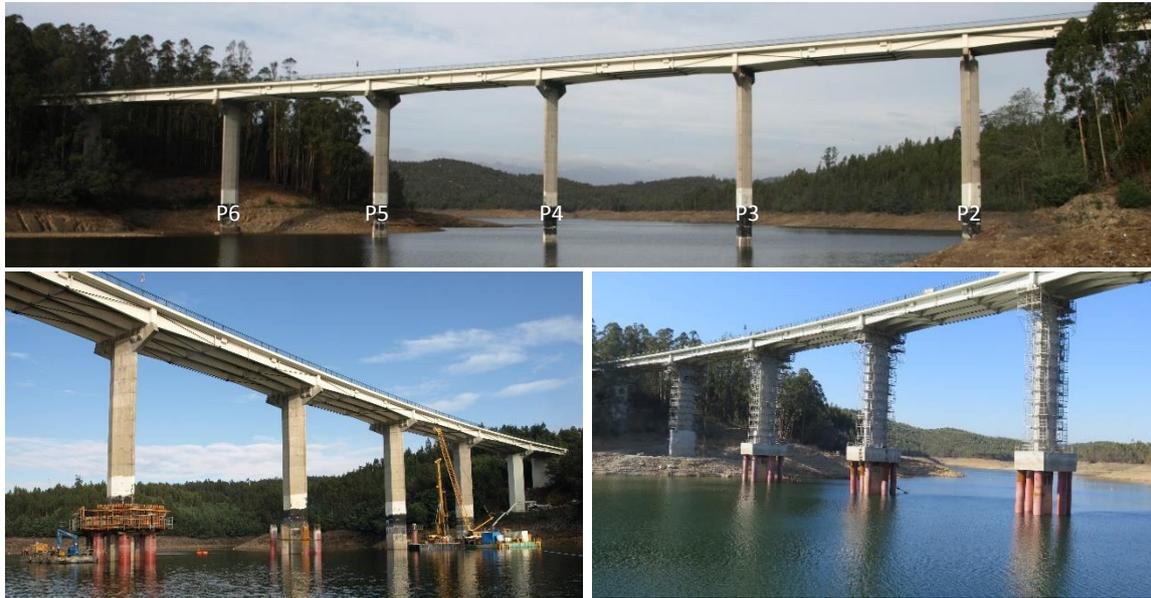
Figure 8 - Criz II bridge before and at during the rehabilitation works (Santos et al., 2022).

The first rehabilitation works on Criz II bridge were carried out between 2007 and 2010, involving the abutments and the deck, including the application of external prestressing in the deck, due to the poor performance of the original prestress system, as well the replacement of the bearing devices and the

installation of damping devices in one abutment to improve seismic performance (pier P3). Fig. 8 and 9 illustrate different aspects of the Criz II bridge.

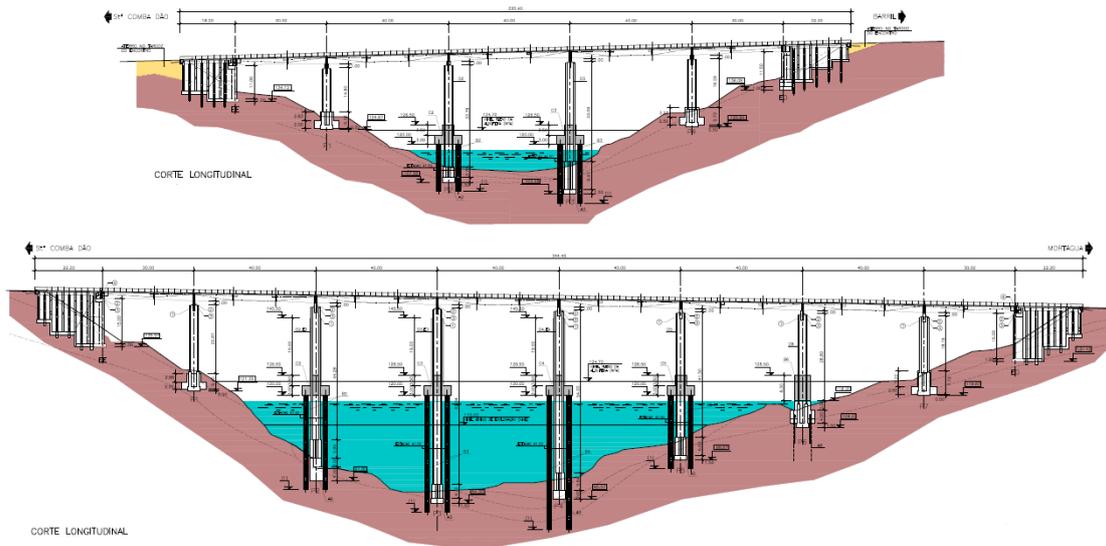
Figure 9 - Intervention solution in the foundations of Criz I and Criz II bridges (Rodrigues et al., 2022).

The structural solution designed for these bridges consisted of the deactivation of existing foundations and shaft pier sections that are immersed in the reservoir, through the execution of a set of several piles with $\phi 1,50$ m, headed by a prestressed pile cap in reinforced concrete, transferring the load from the shafts to the new foundation.

Additionally, in P2, P3 and P4 piers of the Criz II bridge, the strengthening of the shaft through jacketing with reinforced concrete was designed, above the top of the pile cap. This reinforcement was

necessary due to the high stresses in the existing shaft, resulting from local vibration modes associated with the high mass of the pier and water, which exceed their resistant capacity.

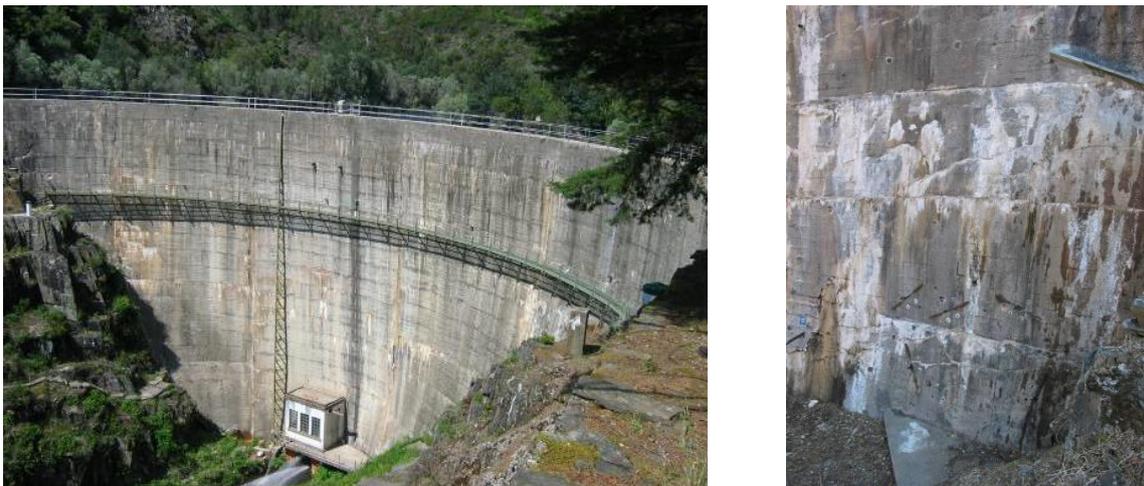
The first evidences of structural anomalies of Alto Ceira dam were observed during the first filling of the reservoir, and have increased since then. The anomalous dam behaviour was characterized by progressive horizontal upstream displacements, progressive upward vertical displacements and intensive cracking. Many studies and tests have been carried out in order to get a better knowledge of the causes of the structural problems. Alkali-aggregate reactions (AAR) in the concrete have been identified as the main cause of the intensive cracking of the thin arch dam structure (Figure 12) (Ramos et al., 1995; Custódio et al., 2020).

Figure 12 - Alto Ceira dam. General view and detail with extensive cracking and exudation (COST TU1402: Quantifying the Value of Structural Health Monitoring).

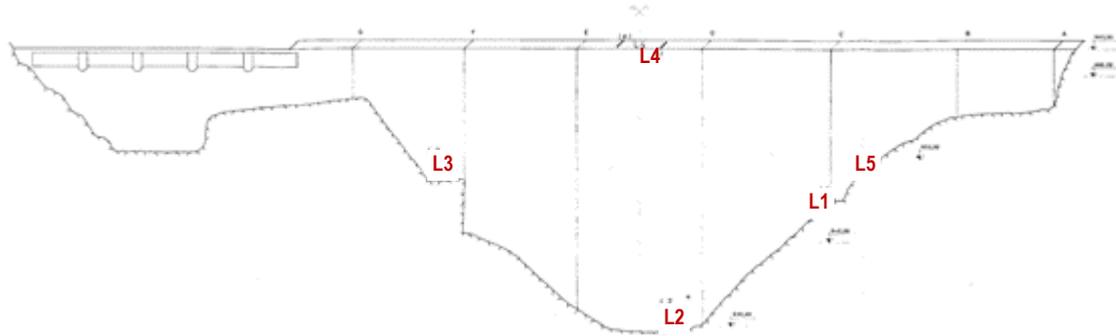
Samples of concrete were collected in 1951 and in 1986 (Fig. 13) to determine the elasticity modulus and the compressive strength of the concrete and it was concluded that at the time the sampling was performed, the concrete was already altered; especially in locations L1 (-29 %), L2 (-26 %) and L5 (-33%). In terms of alteration, the concrete from locations L1 and L5 (block BC, close to joint C) seems to be the most affected, followed closely by that from location L2 (block DE, close to joint D); the concrete from location L3 (block FG, close to joint F) appeared to be the much less altered or not altered at all (+13 %). The results of the mechanical tests show variation for the different areas

Fig. 13 – Alto Ceira dam. Identification of the core extraction locations, in 1986 (Custódio et al., 2020).

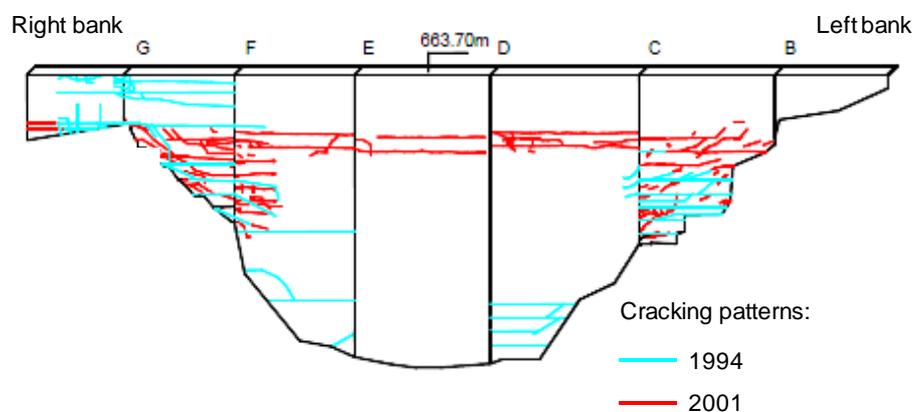
- Between 1986 and 1994 there was no increase in the number of structural cracks, however an increase in the opening of the existing cracks was observed in that period, mainly at the upper levels of the FG block, above the 660 m elevation;
- Between 1994 and 2001, there was an important increase in the number of structural cracks. In some cases, they resulted from the prolongation of the existing cracks observed in 1994;
- There were several cracks in the upstream face, especially near the right abutment;
- Some cracks had significant openings (mainly between 1 and 3 mm) and depths (mainly up to 60 cm). Several cracks were wet, revealing leakage problems throughout the structure.

Fig. 14 – Alto Ceira dam. Evolution of the cracking condition between 1994 and 2001 (Custódio et al., 2020).

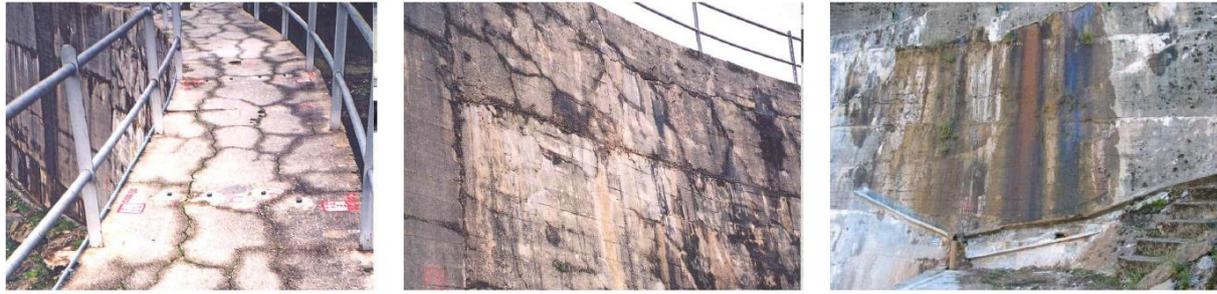
Fig. 15 – Alto Ceira dam. Cracking patterns on the crest and on the downstream surface, and device to measure the leakage through the dam's body (Custódio et al., 2020).

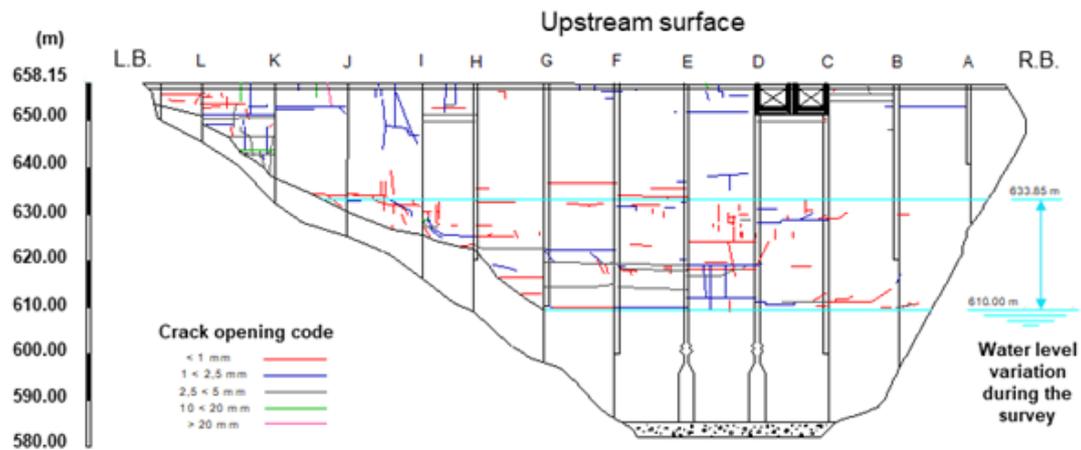
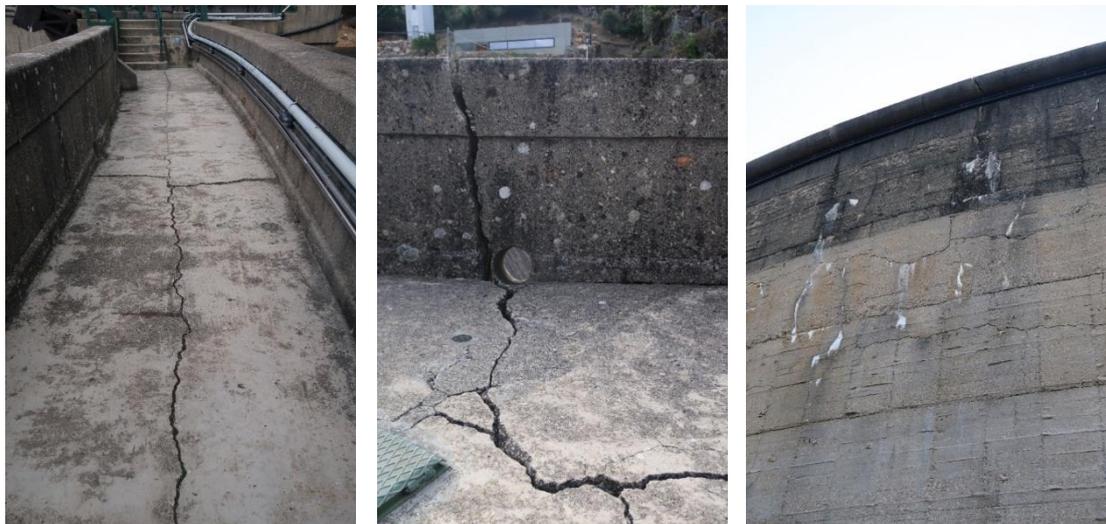
The first signs of the swelling phenomena were identified in 1966, from the results of several geodetic surveys, due to the existence of progressive displacements at the crest, vertical upwards and radial upstream. Linear cracking at the downstream surface, parallel to the foundation, was also detected some years later (Fig. 19).

Figure 19 – Santa Luzia dam. Results of crack survey of upstream surface due in October 1998 (Piteira-Gomes et al., 2022a; Batista, 2022).

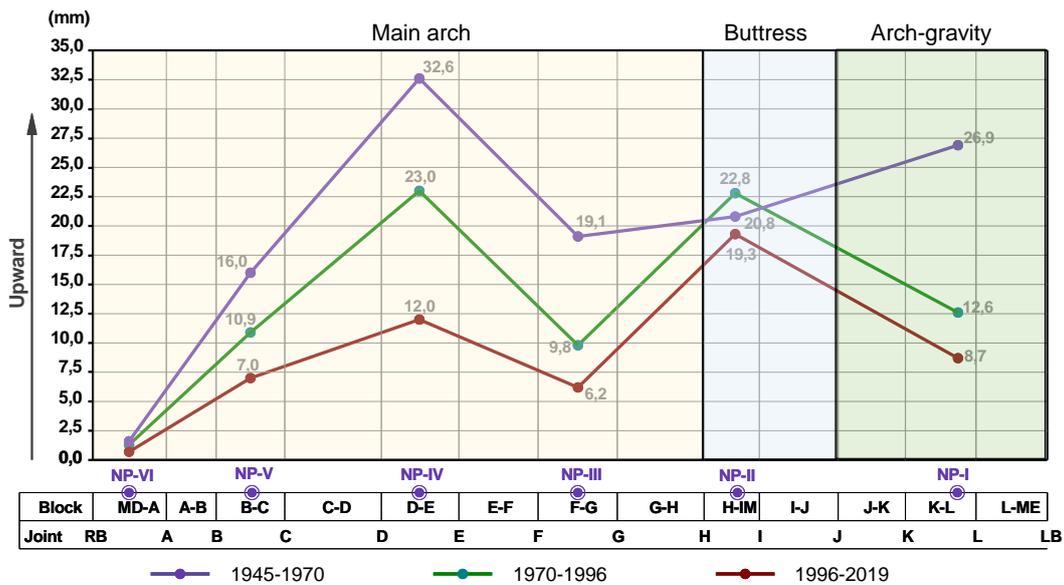
Figure 21 – Santa Luzia dam. Irreversible vertical displacements computed for the levelling marks at the crest in the three periods of analysis (Piteira-Gomes et al., 2021a).

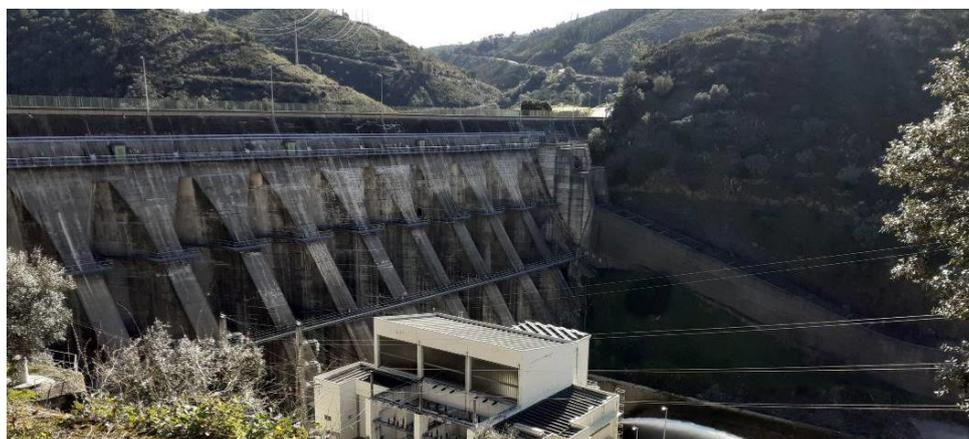
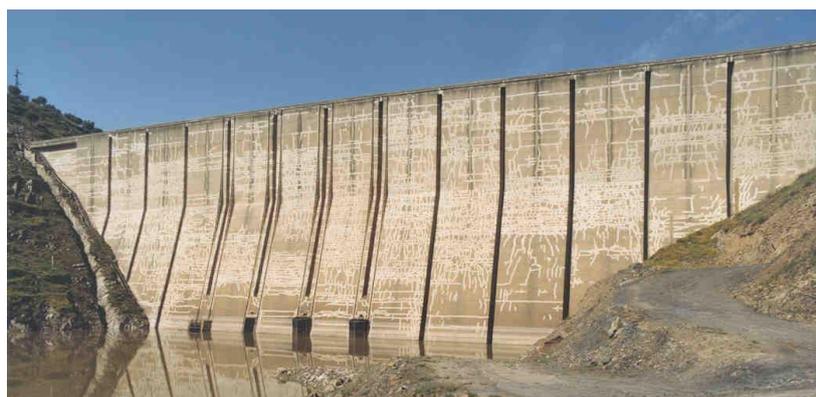
The Pracana dam is a buttress structure, 60 m high, completed in 1951. The dam is founded on a rock mass of phyllite and greywacke alternations and was built with a concrete mix including quartzite and granite aggregates. An abnormal behaviour of the dam was observed since the first filling of its reservoir in 1951, characterized by progressive vertical and axial horizontal displacements (upstream-downstream direction) and extensive cracking. Physical and chemical tests performed over time, on samples taken from the dam's body, confirmed the existence of ISR-ASR of great magnitude. At the end of the eighties of the last century the reservoir remained empty, to allow large scale rehabilitation works that have been implemented from 1988 to 1992 (Fig. 23).

Figure 23 – Pracana dam. Map cracking of the downstream and upstream faces.

The structural rehabilitation of the dam included the following works: i) general treatment of concrete, to its regeneration; ii) placement of an impermeable membrane on the upstream surface, including the construction of an upstream foundation plinth; iii) construction of two sets of concrete struts for locking the buttress webs at the foundation level, one next to the downstream toe and the other in an intermediate position; and iv) consolidation of the foundation and execution of new waterproofing and drainage curtains, being the last ones executed from the top of a plinth built along the dam upstream toe. The improvement of the monitoring system was also done.

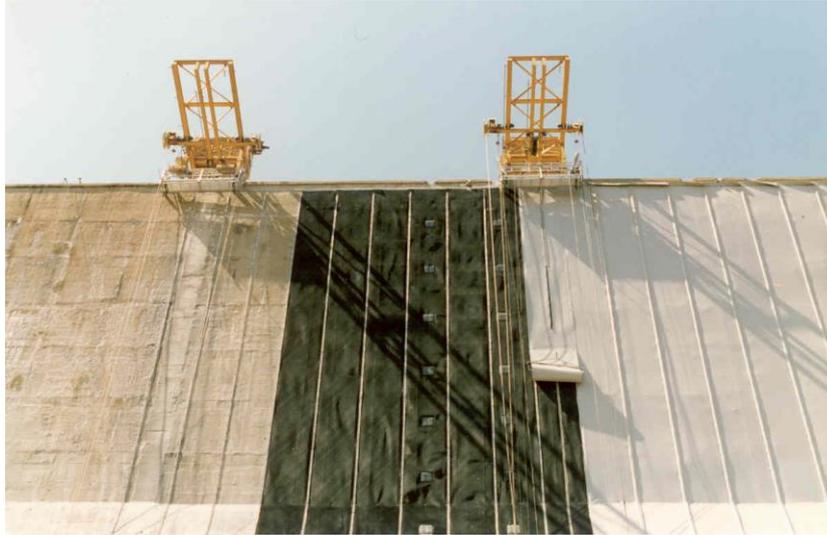
Figure 24 – Pracana dam. Stage of installation of the upstream impervious membrane (Batista, 2022).
